# **Geomorphic Landform Design to Optimize Impoundment Closure**

OSMRE Cooperative Agreement Number: S21AC10058

Draft Final Report

(April 2024)

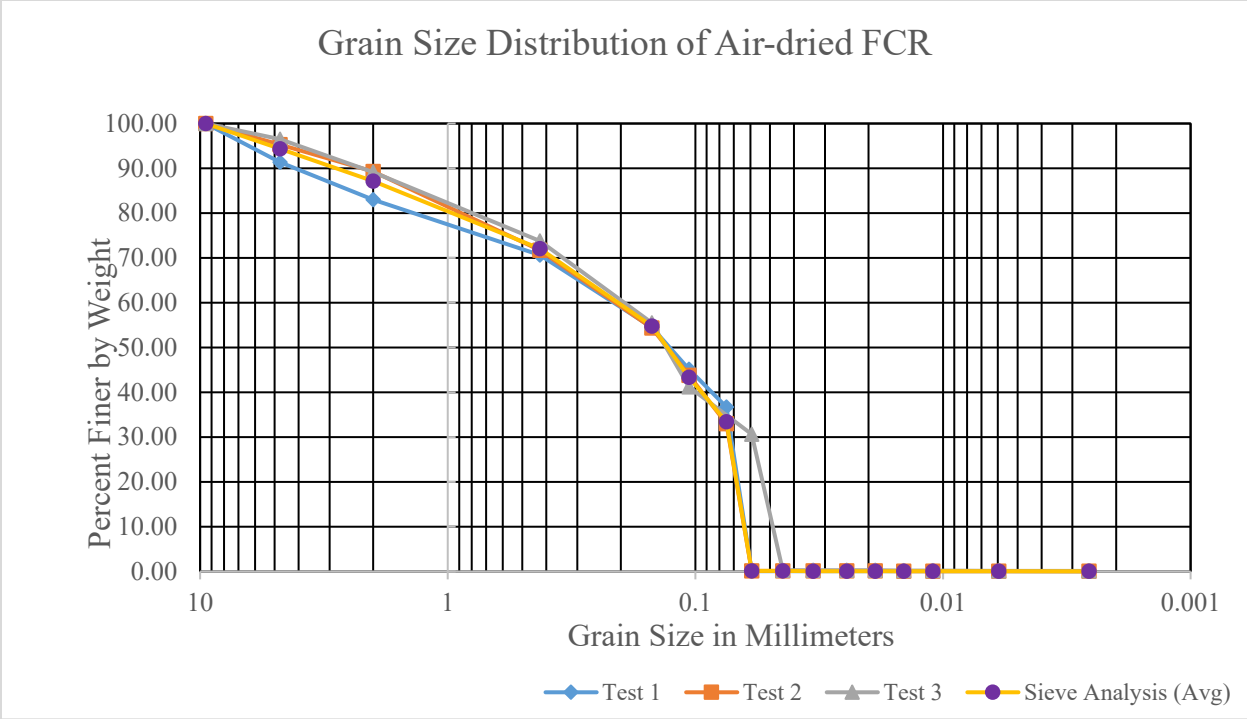
**Figure 2. Grain Size Distribution of Air-dried FCR.**

<b>Air-dried FCR</b>	
<b>Moisture Content (w)</b>	0.27%
<b>Specific Gravity (G<sub>s</sub>)</b>	1.578
<b>Liquid Limit</b>	37
<b>Plastic Limit</b>	28
<b>Plasticity Index</b>	9

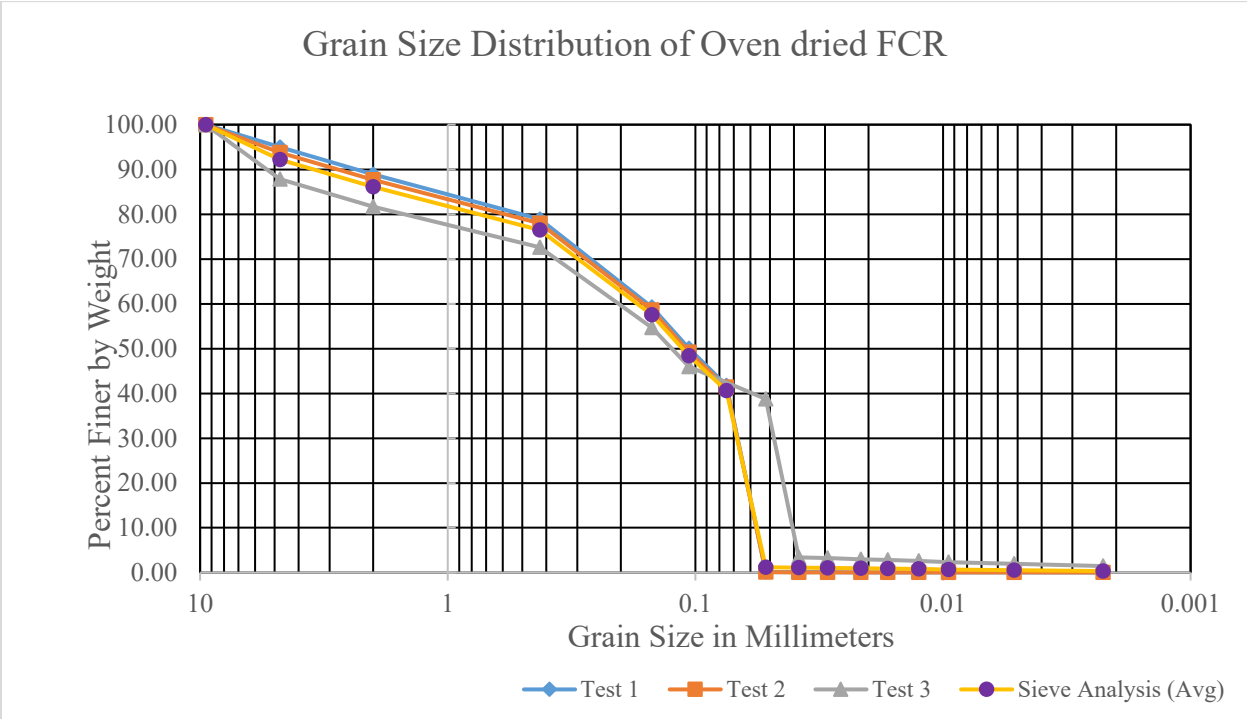
**Figure 3. Grain Size Distribution of Oven dried FCR.**

<b>Oven-dried FCR</b>	
<b>Moisture Content (w)</b>	0.20%
<b>Specific Gravity (G<sub>s</sub>)</b>	1.753
<b>Liquid Limit</b>	35
<b>Plastic Limit</b>	26
<b>Plasticity Index</b>	9

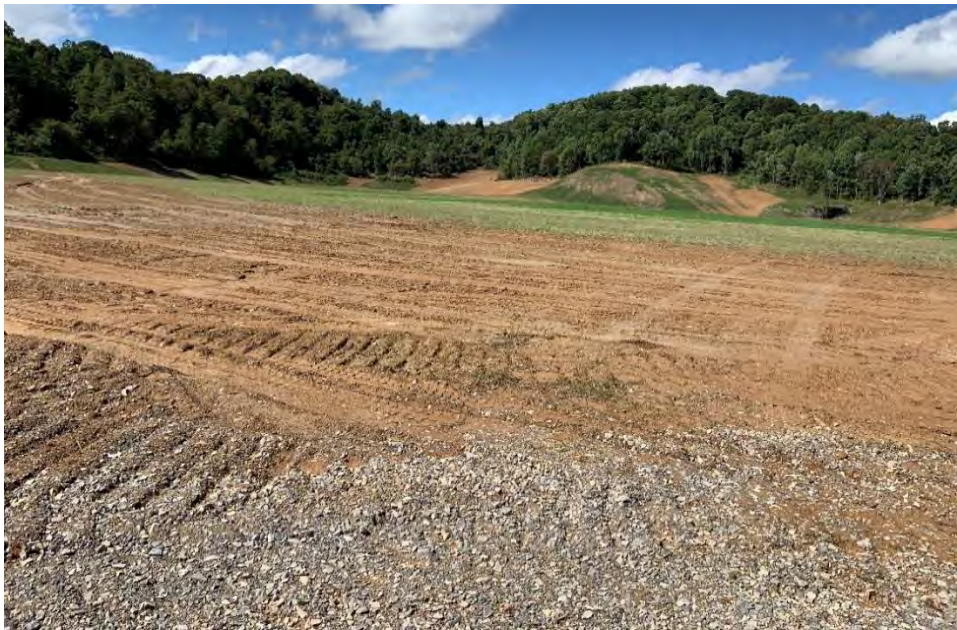
**Figure 17. Filled-in slurry pool.**

With the limited vegetation on the cap, observations on site were easy and concise. Limited settlement had occurred since reclamation. There were no observed low spots, but the ground was still soft. No migration of sediment or clogging of the perimeter drain was observed. The hillside along the end of the impoundment had experienced slope failure, efforts were being made to reclaim it. The planar slope of the cutback dam had no issues at the time of the visit (Figure 19).

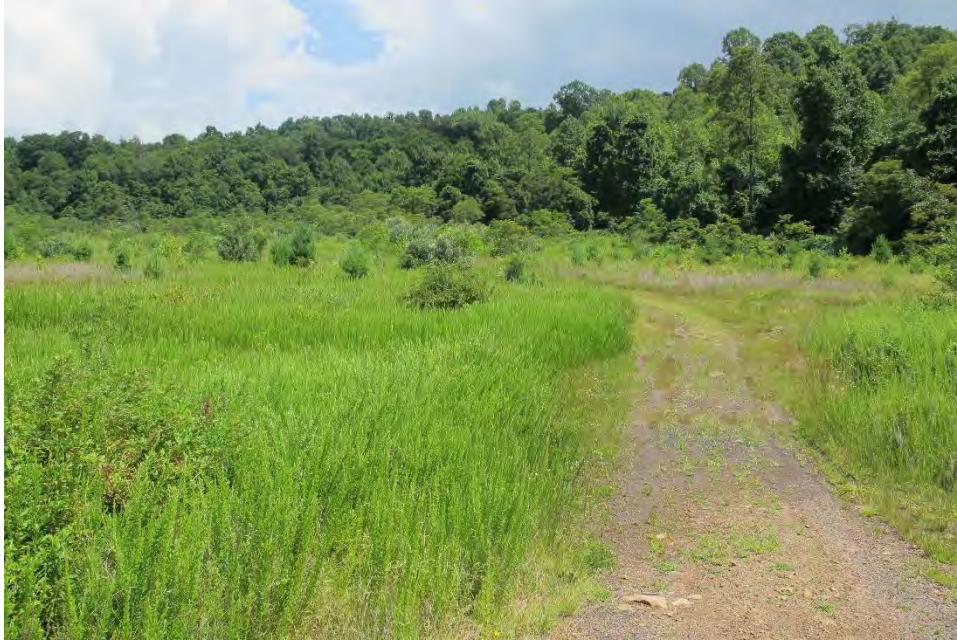
**Figure 31. R070700 Reclaimed impoundment.**

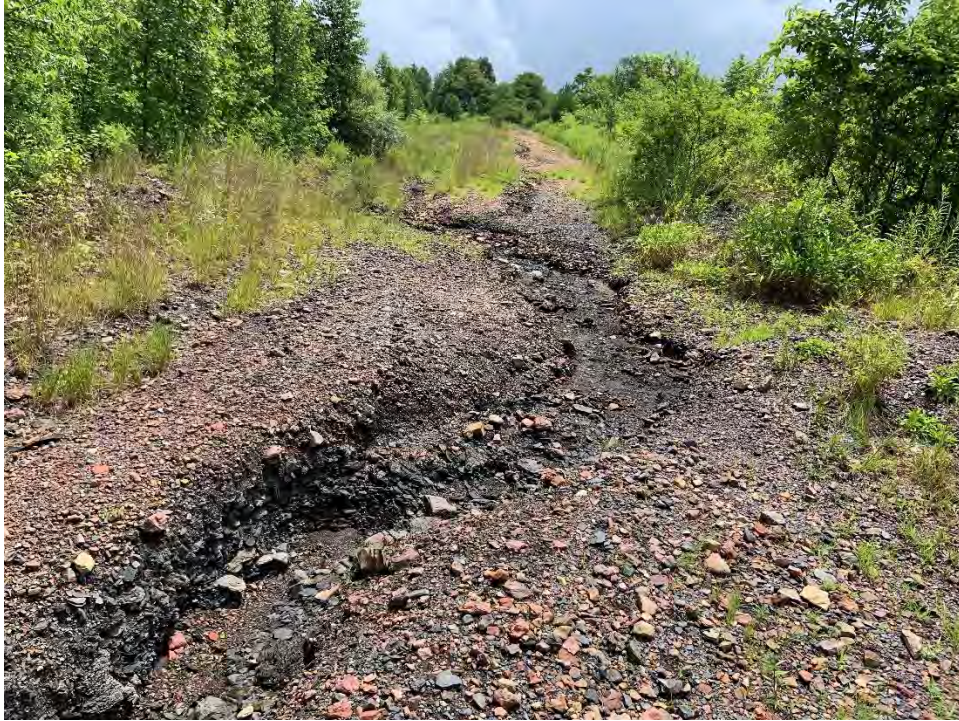
**Figure 32. R070700 Access Road.**

From the site visit, these conclusions were drawn. Recent rains in the area contributed to the water within the impoundment. However, the vegetation within the impoundment was that of a marsh. This combination of events indicates that the impoundment is often saturated, potentially permanent. Constant saturation limits additional surface water infiltration, promoting surface runoff from the site. This allows the excess water to flow and bypass the contact ditch to the steeper and slightly lower grade roadway. The roadway thus experienced gullies, in which the cross-section area changed with the slope.

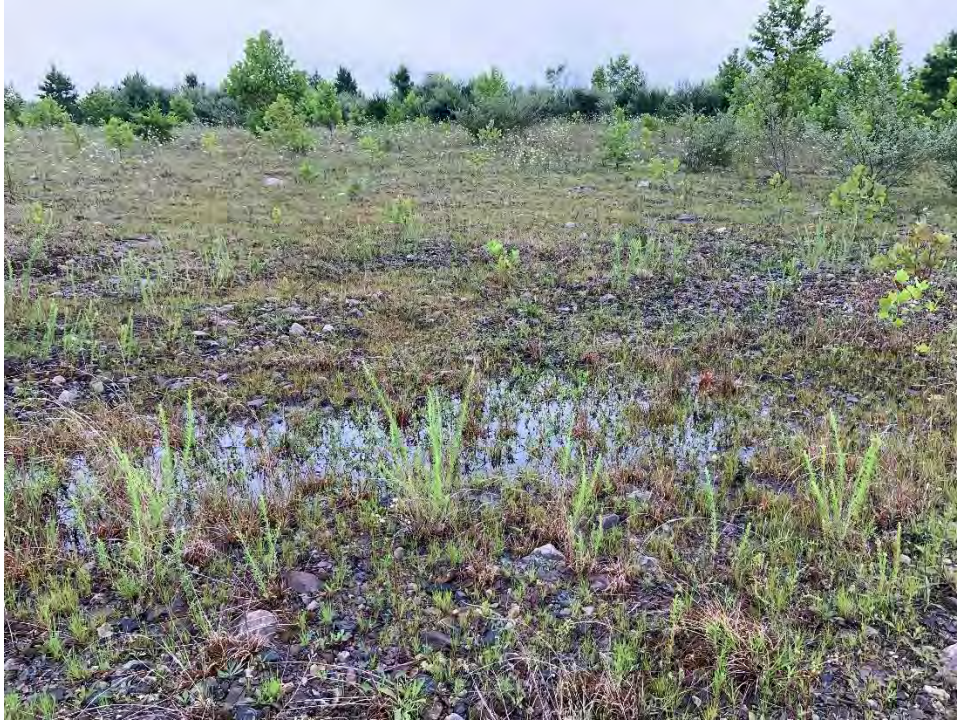
**Figure 46. S003576 Standing water.**

From the site visit, these conclusions were drawn. The cap used at each site was effective in preventing the migration of fine through the structure. With an unlevel surface, water was observed to pond in low lying areas. These observations indicate that the refuse is saturated and re-impounding water.

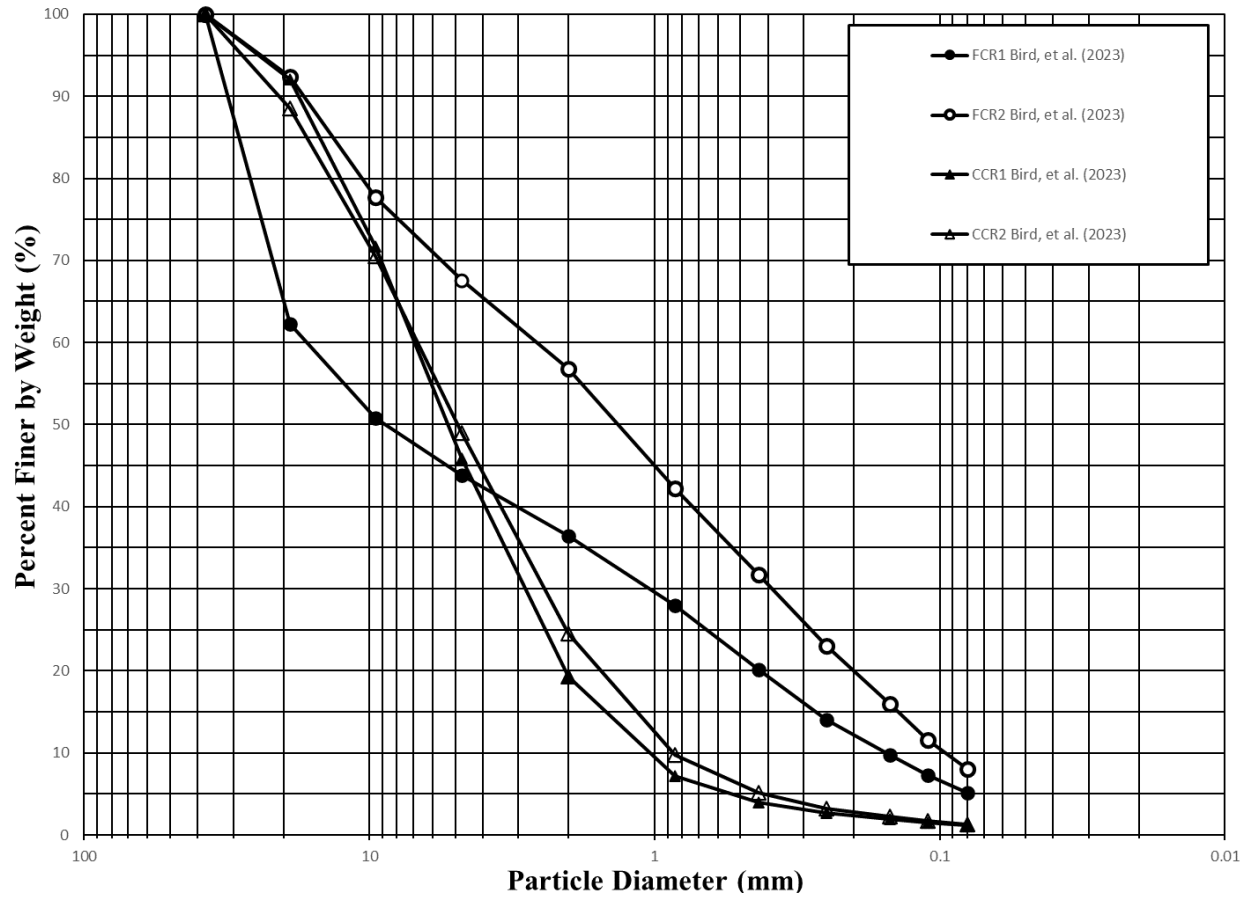
**Figure 48. FCR and CCR grain size distribution.**

<b>Property</b>	<b>CCR</b>	<b>FCR</b>
Specific Gravity, $G_s$	0.938	0.123
Water Content (%)	2.666	0.758
D10 (mm)	4.832	5.219
D30 (mm)	6.952	9.958
D50 (mm)	1.300	6.595
D60 (mm)	2.040	1.624
Passing No. 200 (%)	11.587	25.843

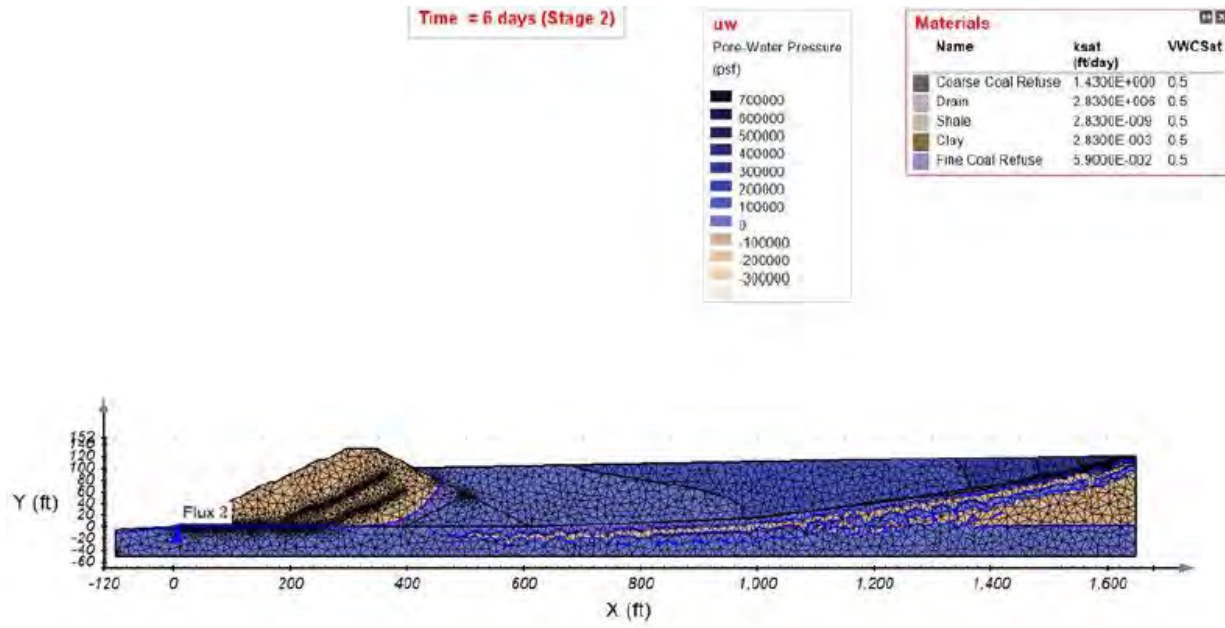
**Figure 54. Century pre-reclamation singular 100-year seepage output.**

<b>Pre-reclamation model results</b>						
<b>Location:</b>	<b>Toe</b>	<b>Mid-slope</b>	<b>Crest</b>	<b>Upstream Slope</b>	<b>Deep Foundation</b>	<b>Slope Search</b>
<b>100-year storm</b>	1.233	1.272	1.229	1.232	1.208	0.848
<b>Repeating 100-year storm</b>	1.229	1.251	1.237	1.232	1.201	0.931

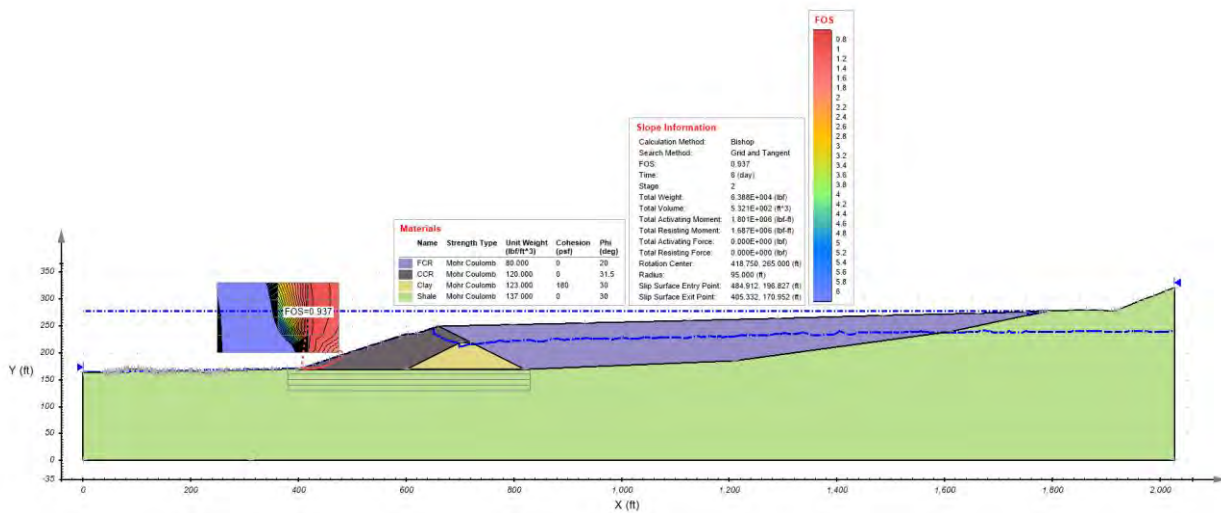
Figure 81. 3 subbasin DePriest deep foundation singular 100-year.

GLD reclaimed model results (3 subbasin DePriest)						
Location:	Toe	Mid-slope	Crest	Upstream Slope	Deep Foundation	Slope Search
100-year storm	0.995 (B)	1.071	1.614 (B)	N/A	0.937 (B)	1.187 (B)
Repeating 100-year storm	0.919 (B)	0.924	1.341 (B)	N/A	0.900 (B)	1.165 (B)

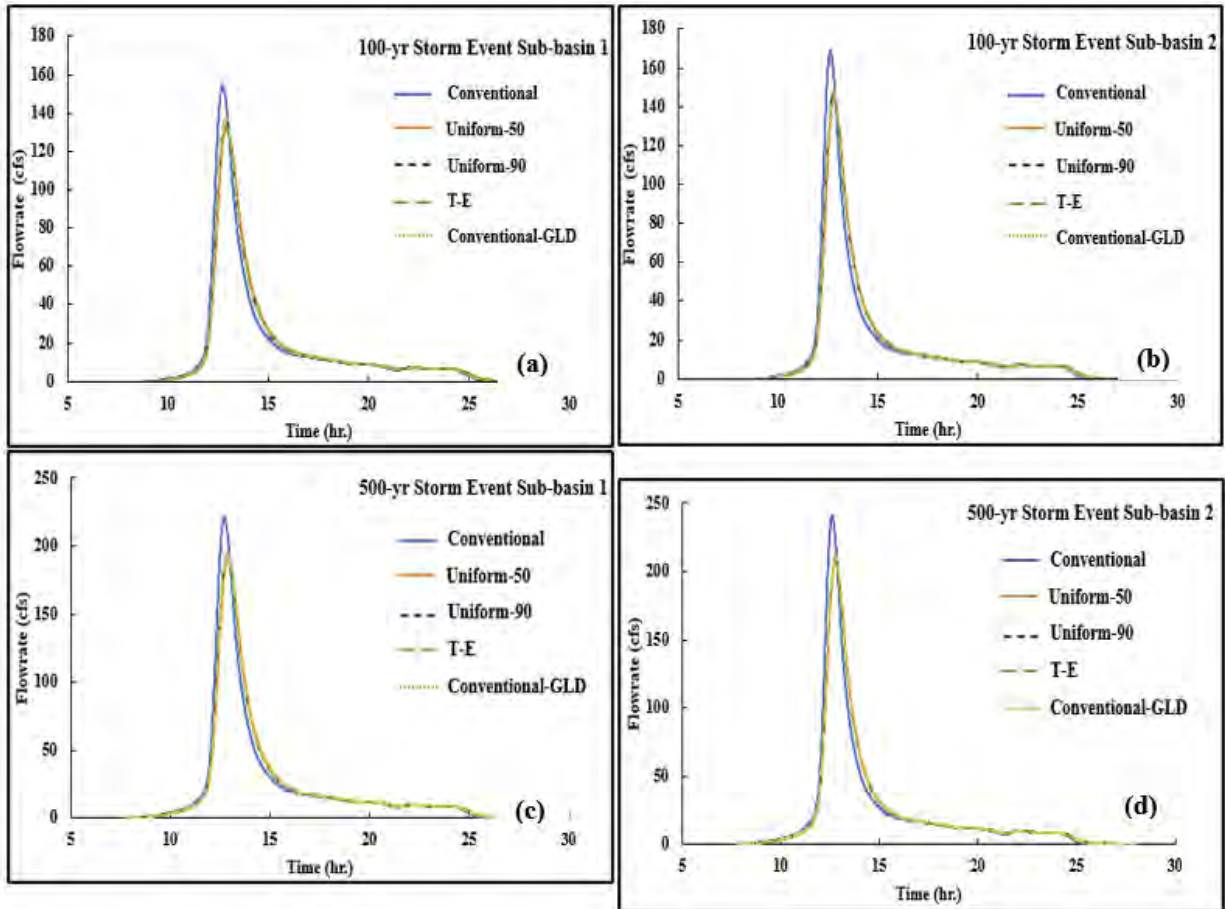
**Figure 154. Runoff hydrographs: 100-year storm event a) sub-basin 1 and b) sub-basin 2 and for the 500-year storm event c) sub-basin 1 and d) sub-basin 2.**

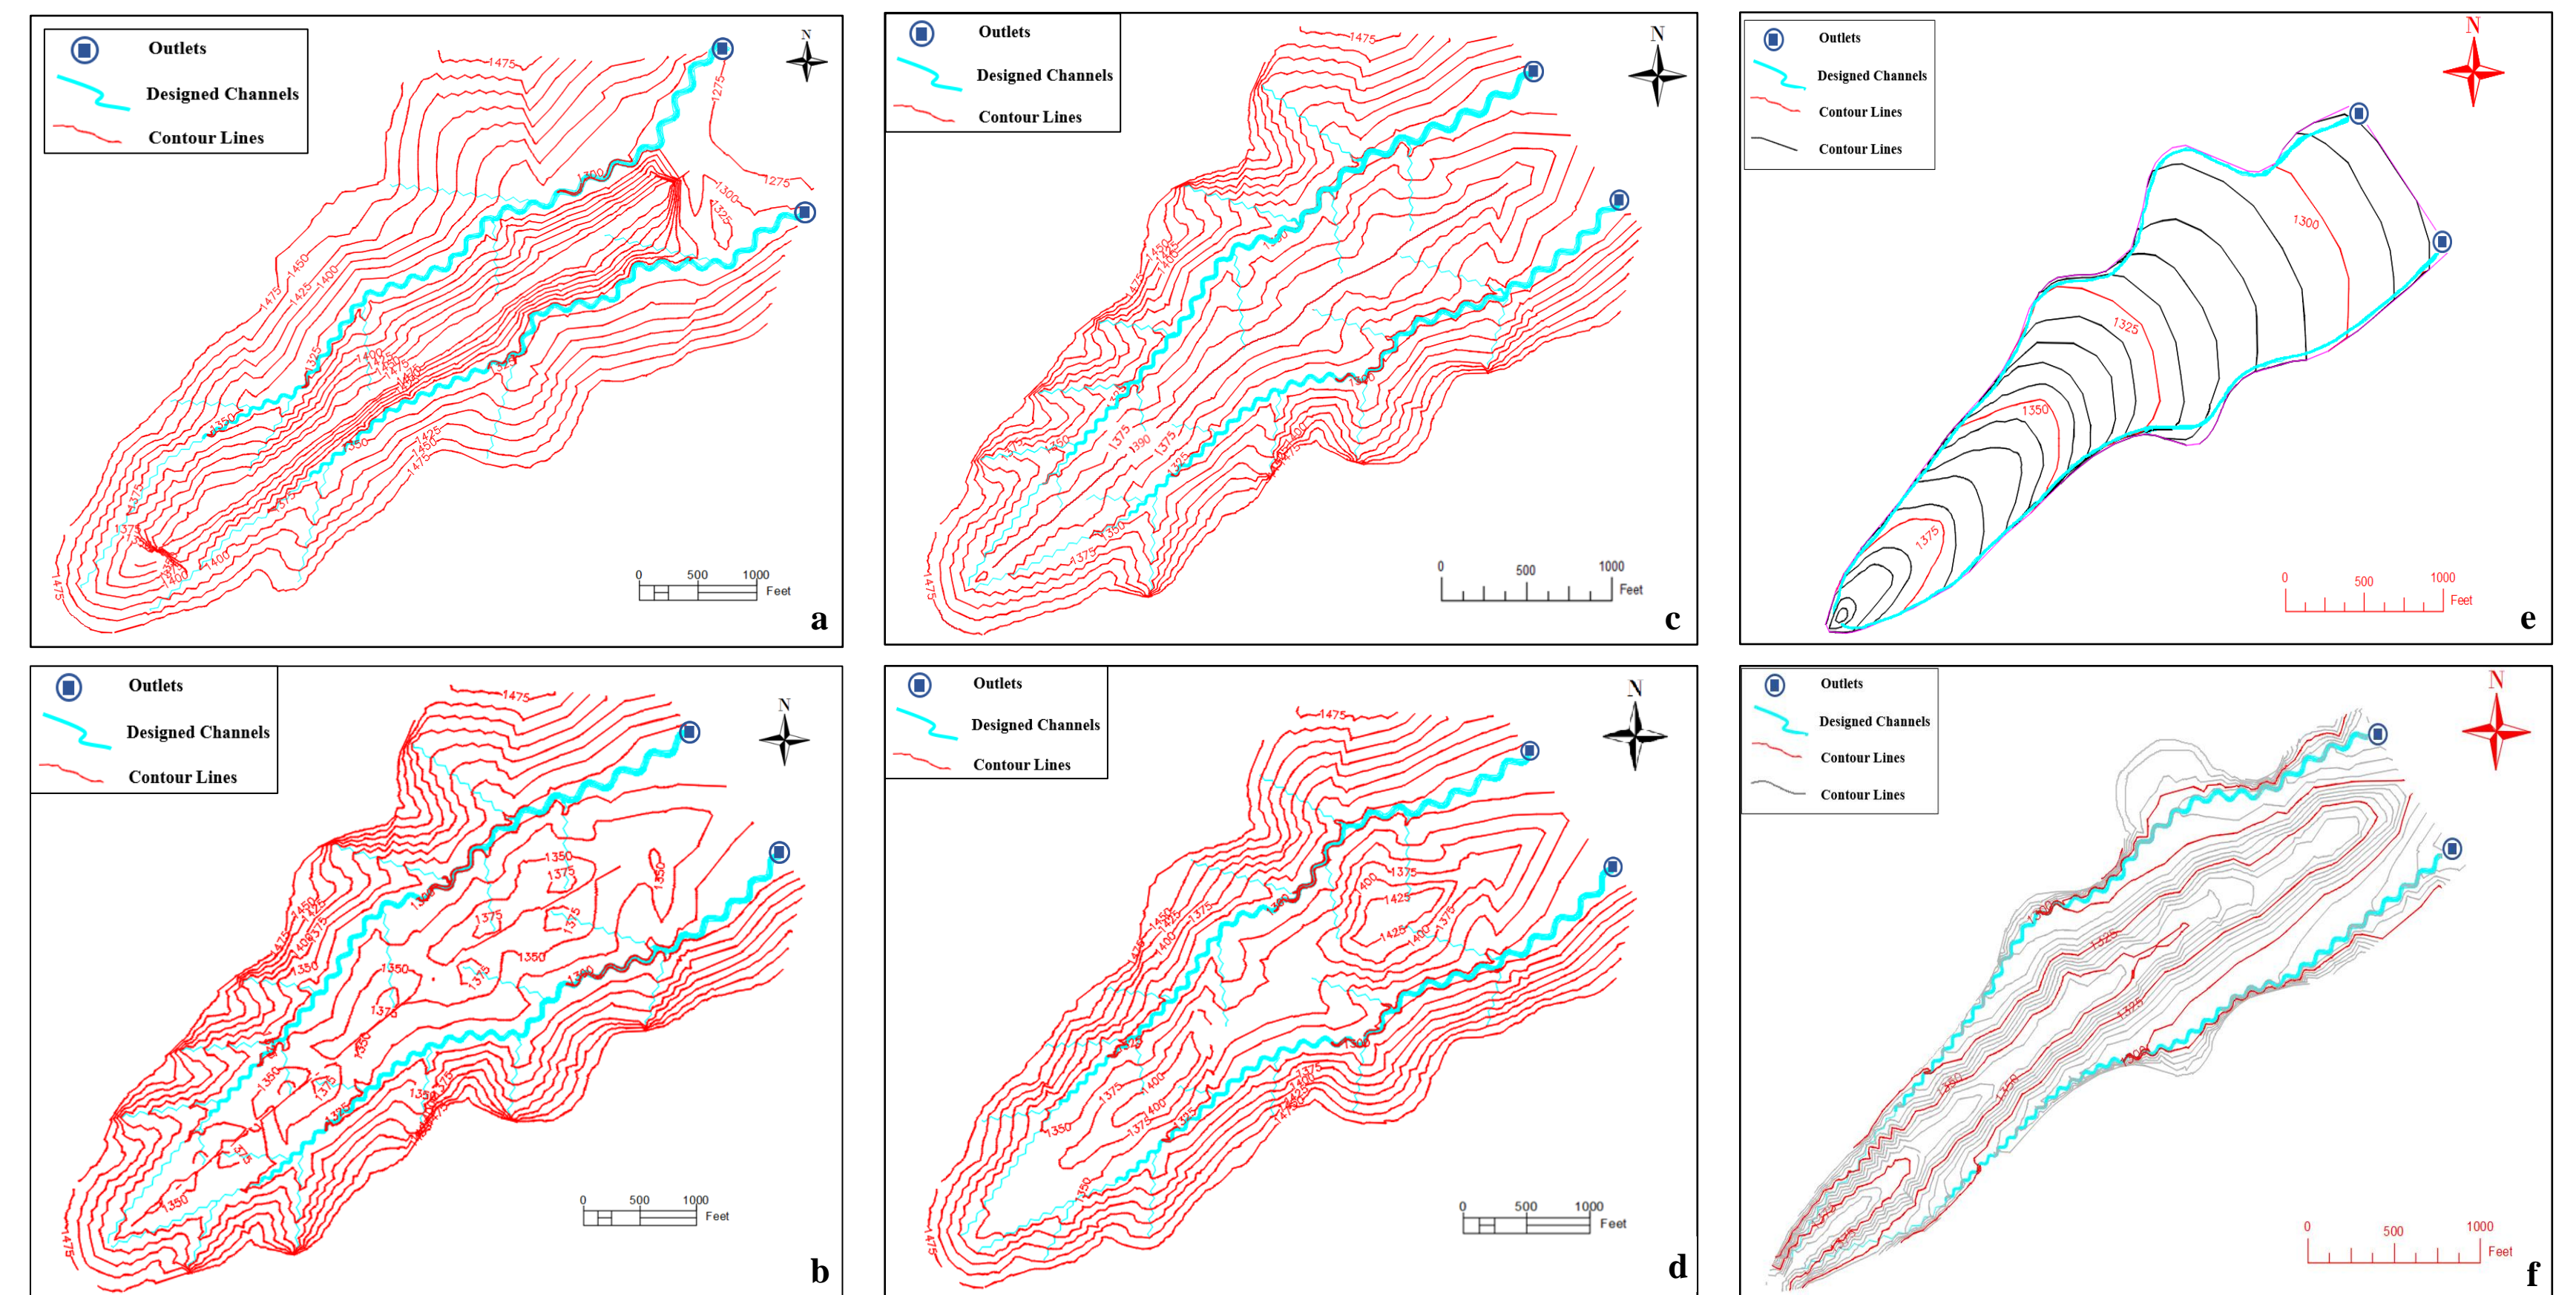
Figure 3: Contour Lines of Created Conceptual Reclamation Designs
